Armory (0006)

Classroom Repairs Phase 2

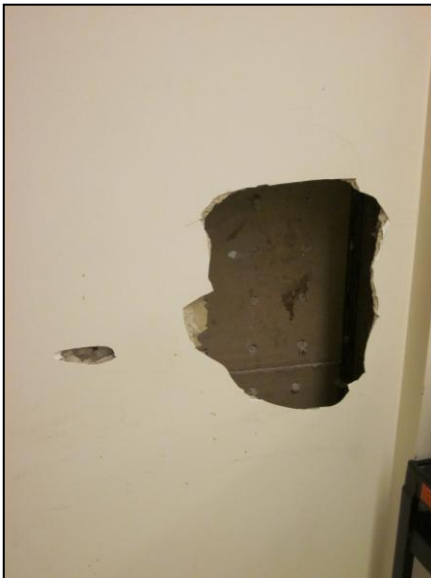
Left Above
Room 331
Wall damage

The project will **replace aged & deteriorated vinyl asbestos tile** in all **classrooms** and associated hallways, as well as **repair and repaint walls**. **Classroom IT systems** and **new seating** will be provided in rooms that do not yet have sufficient equipment or furnishings.

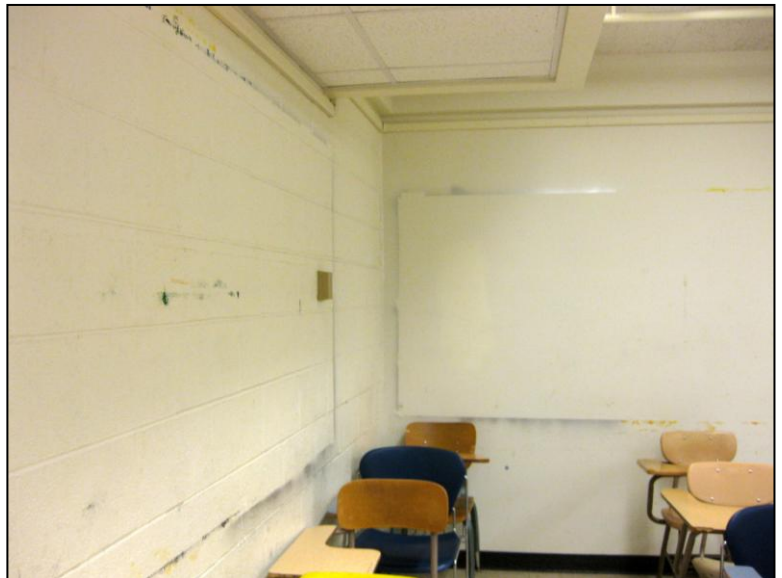
Right Above
Room 328
Poor wall finish conditions

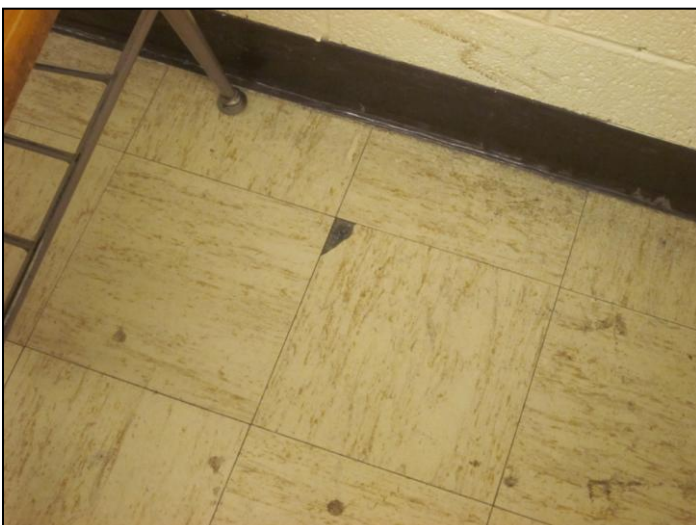
Left Below
Room 429
Damaged flooring

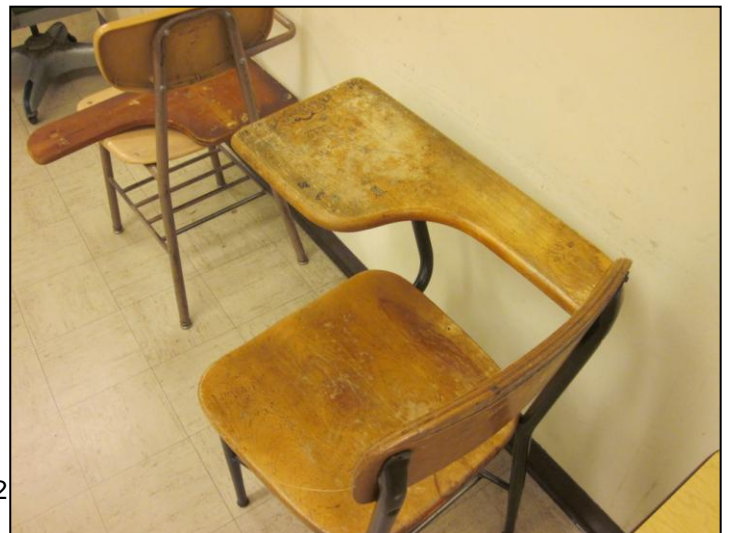
Right Below
Room 429
Aged & damaged seating
